Fish Passage Design Aids Wildlife Crossing in Washington State – State of the Practice

Jon Peterson, corresponding author (360-705-7499, peterjn@wsdot.wa.gov) Fish Passage Coordinator, Environmental Services Office, Washington State Department of Transportation, P.O. Box 47331, Olympia, WA 98504-7331, USA

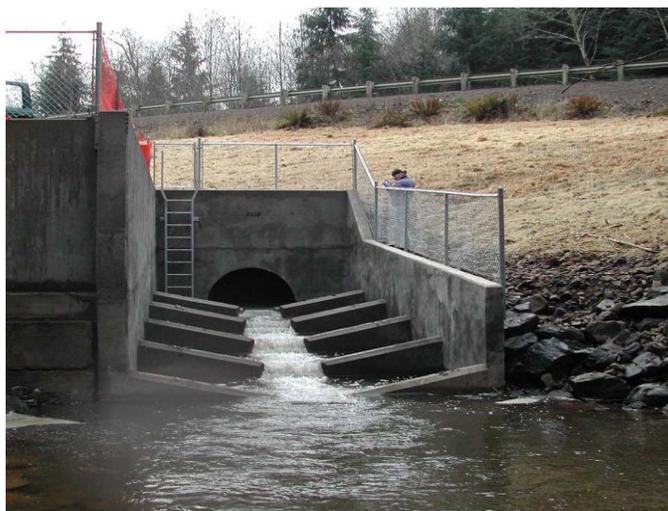
23
24 **FIGURE 1- A steel culvert was assessed as a barrier due to slope & water velocity at Cement Creek.**
25 **This culvert was retrofitted with a pool -and- chute fishway for \$200,000 in 2002 (milepost 8.8 on SR**
26 **401 in the southwest corner of WA).**

10 In addition to culverts, WSDOT owns & maintains 160 fishways (Figure 1) statewide. During the 1990's,
11 many WSDOT fish passage barriers were retrofitted with fishways, as an interim fish passage repair. Fishways,
12 commonly called fish ladders, are structures built to facilitate passage of fish through, over, or around an instream
13 barrier. Most fishways enable fish to pass around the barriers by swimming and leaping up a series of relatively low
14 steps.

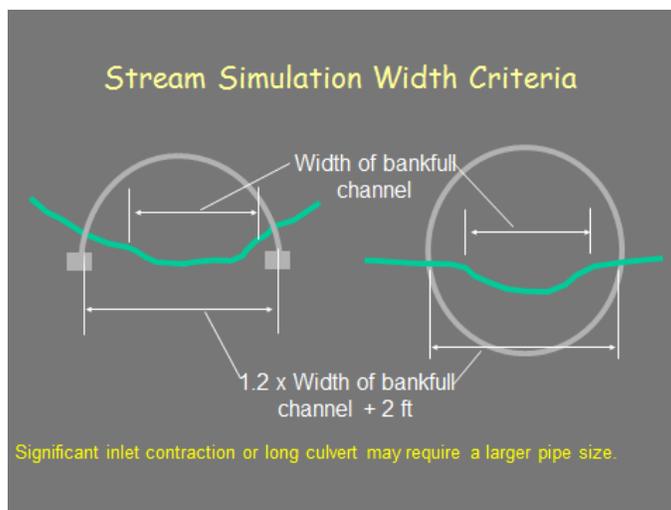
25 **FIGURE 2- Stream Simulation Width Criteria (courtesy of the Washington Department of Fish & Wildlife)**

18 WDFW started a new approach to stream design around 1999 called "stream simulation" and formalized
 19 this method in their "Design of Road Culverts for Fish Passage (2003 edition). The premise for stream simulation is
 20 that if fish can migrate through a natural channel, they can also migrate through a man-made culvert and channel
 21 that simulates the natural channel. Stream simulation structures carry a stream with all the appearance of a natural
 22 streambed and span an area wider than the existing stream channel and sloped to a similar gradient (Figure 2). This
 23 design method attempts to mimic the natural conditions that occurred prior to the culvert's placement in the stream.

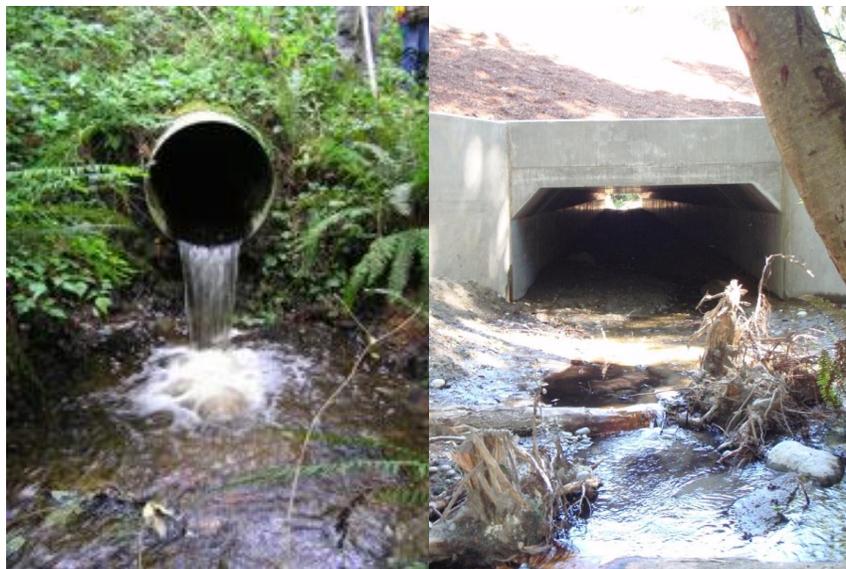
2 **FIGURE 3- A 0.7 m (2.2 ft) round culvert was replaced with stream simulation designed 3.6 m (11.8 ft)**
 3 **span x 1.8 m (6 ft) rise bottomless concrete box at an Unnamed Tributary to Squamish Harbor on SR 104**
 4 **at milepost 12.30 near the Hood Canal Bridge.**

26 Stream simulation provides for larger stream widths that promote sediment and woody debris passage
 27 through the structure during high flow events (Figure 3). Additionally, stream simulation designed crossing
 28 structures allow small and medium sized animals to travel through the crossing structure because the streambed
 29 margins are usually dry or the water is shallow enough that the animals will wade the stream. The latest stream
 30 simulation design guidance and its history can be found in the 2013 edition of WDFW's *Water Crossing Design*
 31 *Guidelines*.

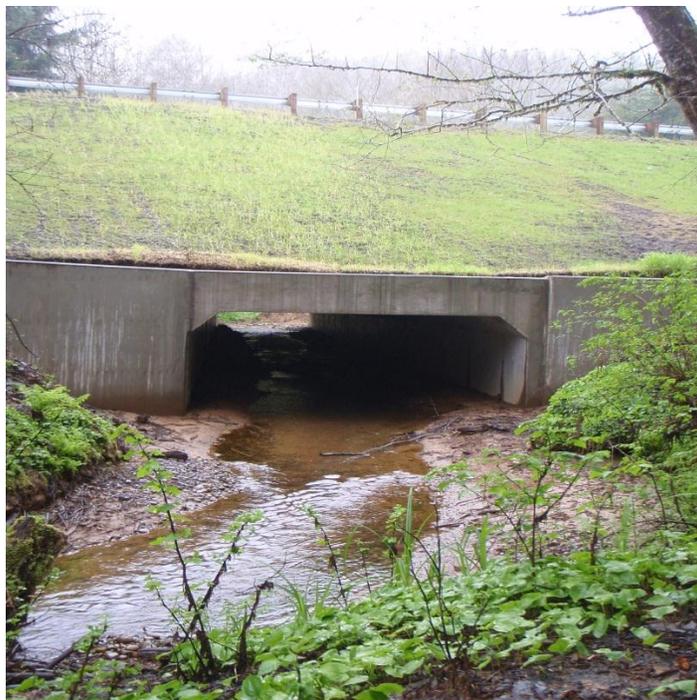
2 **FIGURE 4- A round culvert was replaced with stream simulation designed 4.9 m (16 ft) span x 2.9 m (9.5 ft) rise**
 3 **bottomless concrete box culvert at Mosquito Creek on US 101.**

15 Quantification of wildlife use of WSDOT stream simulation designed culverts and bridges began in April
 16 2010 when motion-triggered cameras were deployed at both ends of the Mosquito Creek box culvert (Kintsch &
 17 Cramer 2011). A 1.2 m (4 ft) round culvert was replaced with a stream simulation designed culvert that is 4.9 m (16
 18 ft) wide at Mosquito Creek on US 101 at milepost 76.48 southeast of Aberdeen, WA. This new fish friendly culvert
 19 provides 3.5 km (2.2 mi) of upstream habitat for fish and habitat connectivity for wildlife (Figure 4).

20 The Mosquito Creek culvert was designed by WSDOT and constructed during the late summer and
 21 early fall of 2009. The engineer’s estimate for construction was \$868,331 and the low winning bid was
 22 \$728,349. The total cost of the project with design and permitting was \$1,428,863. The cost of the box culvert,
 23 itself, was \$92,000 in the low bid.

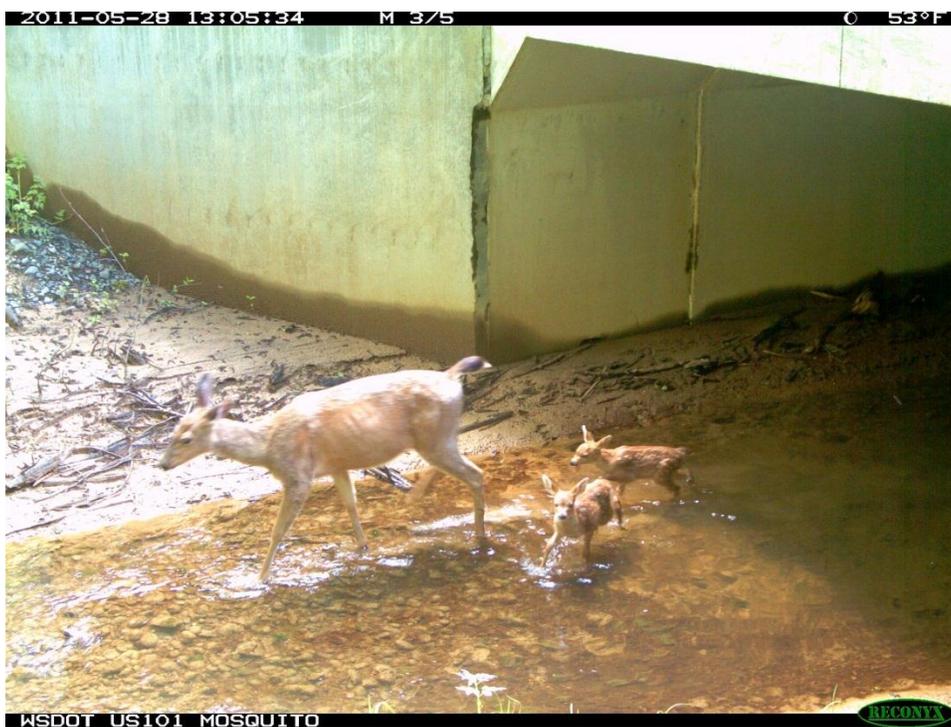
FIGURE 5- A doe & two fawns utilizing the Mosquito Creek culvert on US 101 in 2011.

4 In 138 days of camera monitoring, 60 black-tailed deer and 18 raccoon crossings were documented. Many
 5 of the crossings involved a doe with two fawns (Figure 5).

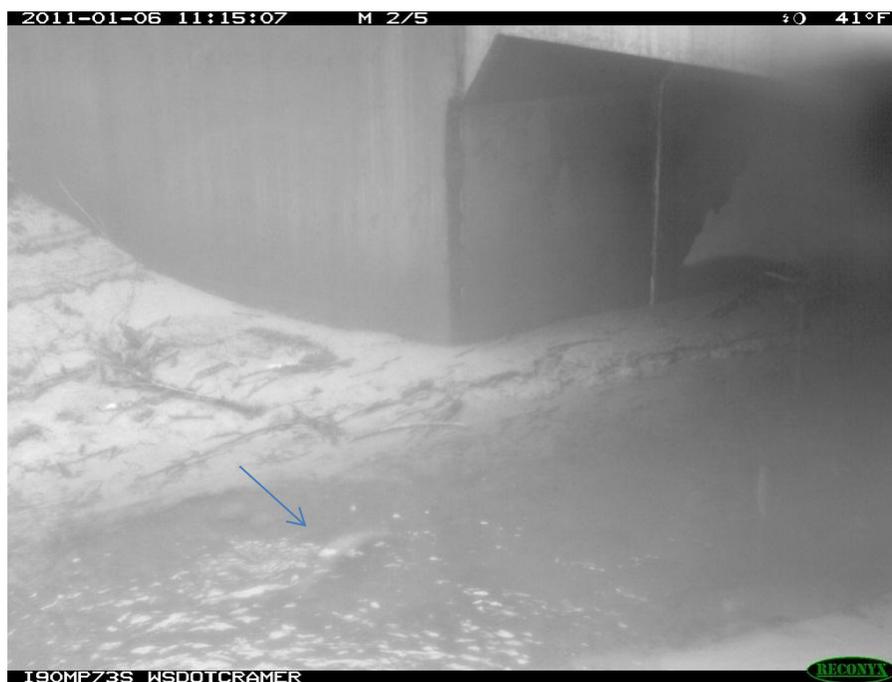
16
 17 **FIGURE 6- A large salmon (possibly coho) triggers the wildlife camera in January of 2011 at Mosquito Creek.**

12 Spawner surveys were conducted at Mosquito Creek pre-project in 2006 & 2007 and one adult coho
 13 salmon was seen downstream and one adult coho upstream. Post project surveys were completed in 2009 &
 14 2010 with upstream observations of 4 adult coho salmon and 2 salmon redds (egg nests) in 2009 and 3 adult
 15 coho salmon and 2 salmon redds in 2010 (Figure 6).

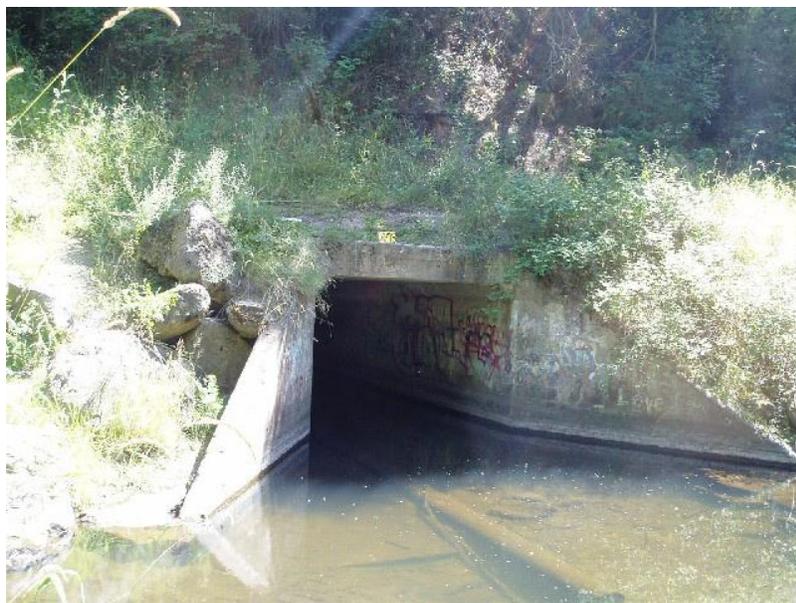
2 **FIGURE 7- This concrete box culvert at Deadman Creek on US 2 was considered a barrier due to excessive water**
 3 **velocity during high flows.**

18 At Deadman Creek on U.S. 2 north of Spokane, a 2.4 m (8 ft.) box culvert (Figure 7) was replaced
 19 with a stream simulation designed steel plate arched culvert as part of a larger transportation project during the
 20 late summer and fall of 2010. The new culvert opened up approximately 92 km (57 mi) of potential upstream
 21 habitat for resident cutthroat trout.

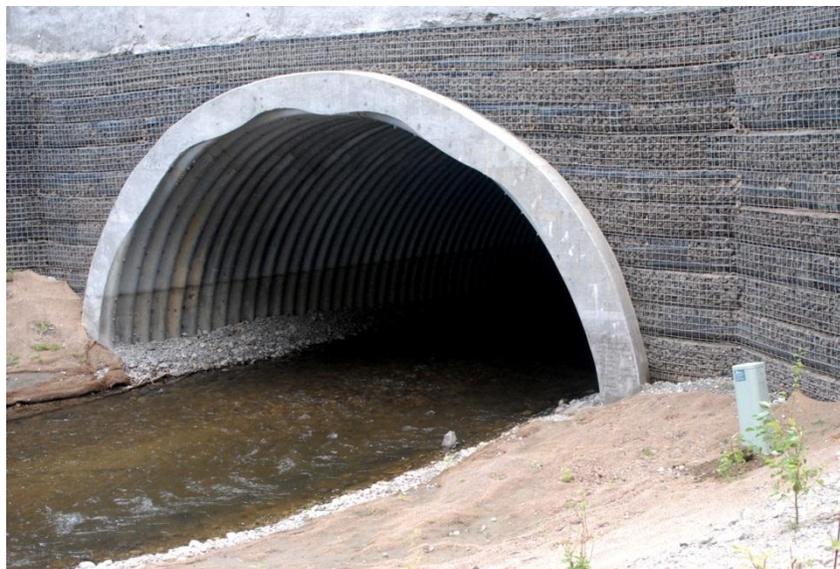
8 **FIGURE 8- The new Deadman Creek culvert just north of Spokane, WA at milepost 296. One of the wildlife cameras**
 9 **is in the green utility box in the right of the photo.**

4 The new culvert has a 9.1 m (30 ft) horizontal opening and a 4.6 m (15 ft) vertical opening, and is 34.1 m (112
 5 ft) long (Figure 8). There is no cost information for this culvert as it was part of a much larger \$42.8 million
 6 dollar transportation project built just north of Spokane, WA.

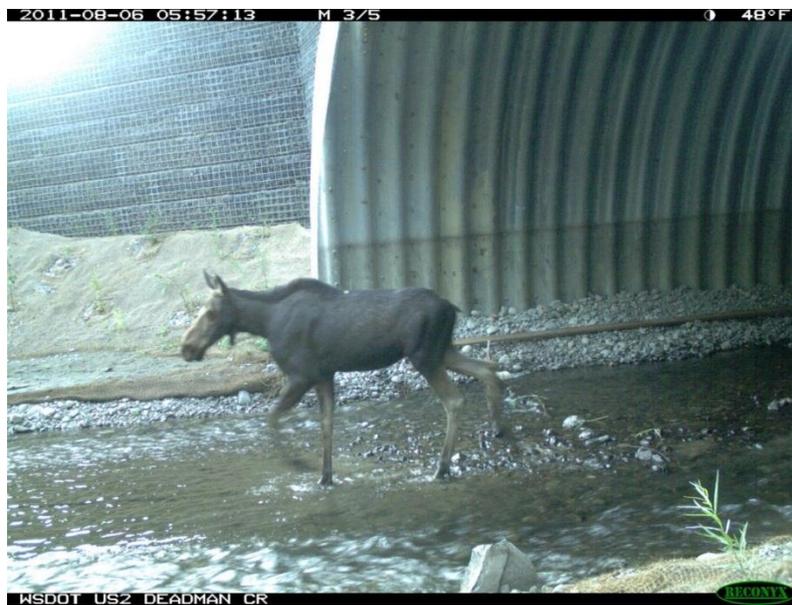
2 **FIGURE 9- A moose traversing the stream simulation designed culvert at US 2 Deadman Creek near Spokane, WA**3 **BRIDGE FOR FISH & WILDLIFE**

10 As construction was nearing completion, White-tailed Deer began using the structure, and, at the end of ten
 11 months of monitoring, 1,241 White-tailed Deer crossings had been documented, an average of more than 4 deer
 12 crossings per day. An image of a moose was captured by the cameras as well (Figure 9).

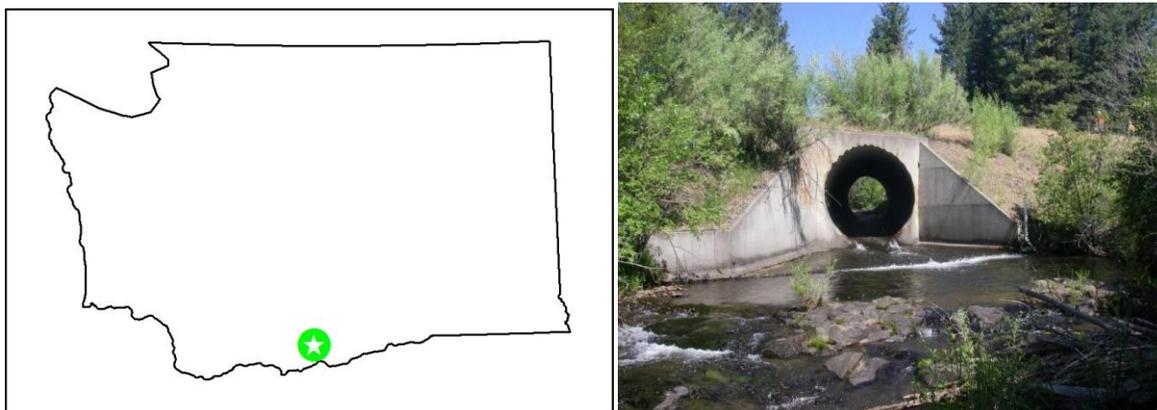
15 **FIGURE 10- This undersized 3.2 m (10.5 ft) round culvert in Klickitat County was be replaced in 2012 with a**
 16 **19.8 m (65 ft) bridge with a 3 m (10 ft) wildlife bench incorporated into the channel design at milepost 21.35.**

1 WSDOT conducted a reach analysis (Schanz, 2010) at Butler Creek to examine the hydrologic and
 2 geomorphic factors that should be considered when the culvert was replaced. It was determined that a 9.1 m
 3 (30 ft) channel width would meet the WDFW Stream Simulation design criteria plus an additional 3 m (10 ft)
 4 for a wildlife bench. The final cross section under the bridge was 13.1 m (43 ft) in total with an active channel
 5 width of 8.2 m (27 ft) and a wildlife bench width of 3 m (10 ft).

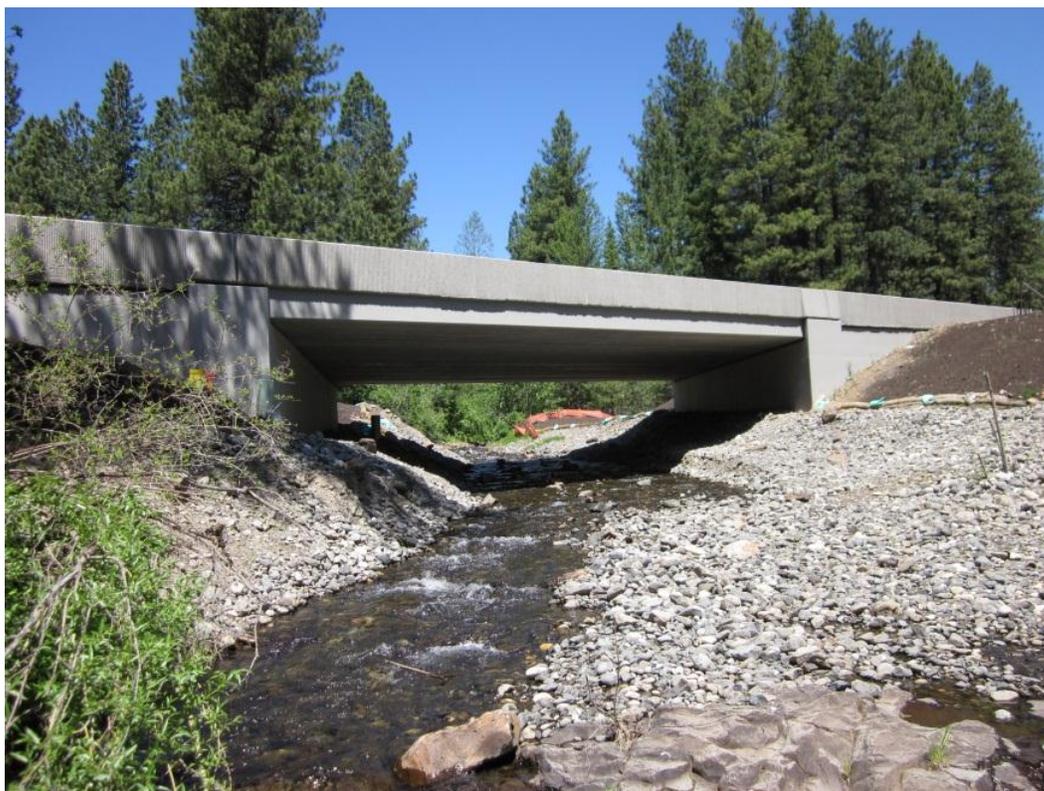
12
 13 **FIGURE 11- The new 19.8 m (65 ft) bridge constructed in 2012 at US 97 Butler Creek near Goldendale, WA**

6 WSDOT biologists worked with WSDOT design engineers to purposely construct a 19.8 m (65 ft)
 7 bridge span (Figure 11) with a new stream channel underneath that includes a 3 m (10 ft) wildlife bench and at
 8 least 2.7 m (9 ft) of height (rise) for deer and other wildlife. The average height of the bridge after construction
 9 from the center of the stream to the bottom of the bridge is 3.9 m (13 ft). The inclusion of barrier fencing,
 10 jump-downs, and wildlife guards followed recommendations in the Wildlife-Vehicle Collision Reduction Study
 11 – Report to Congress from the Federal Highway Administration.

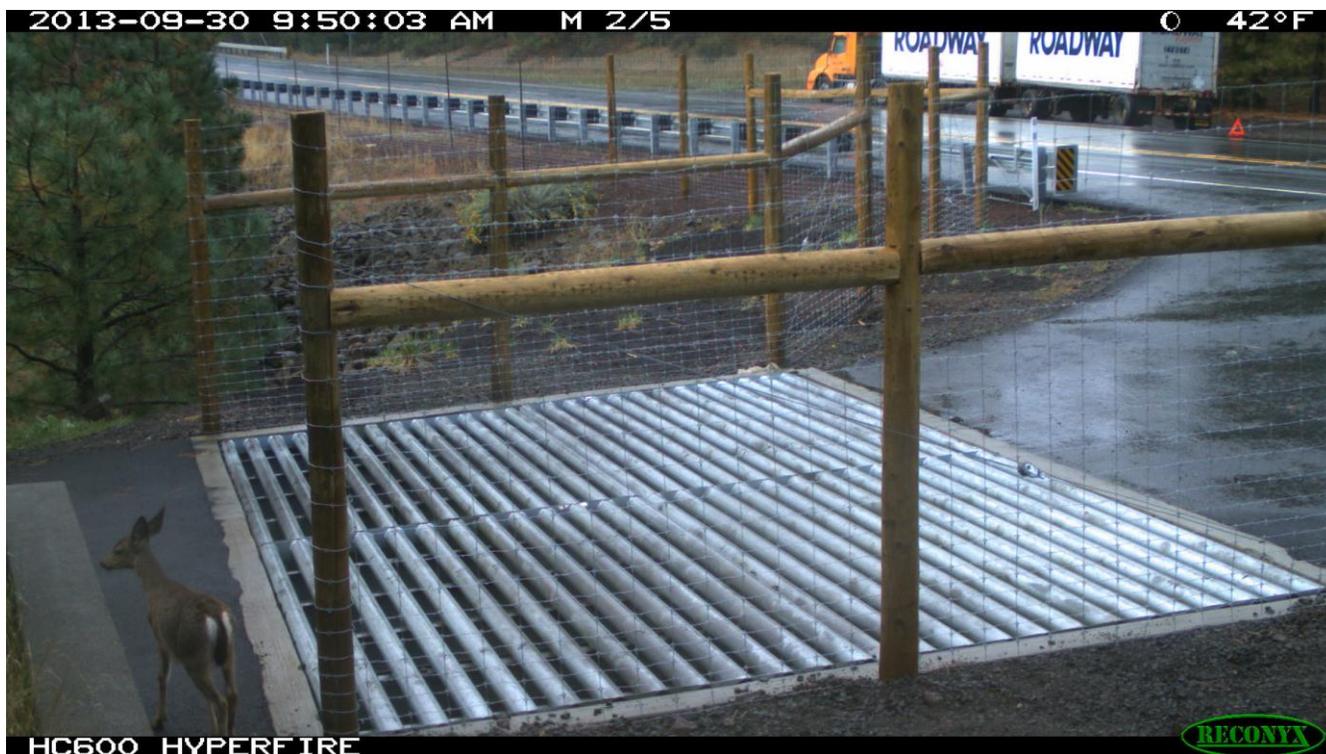
2 **FIGURE 12-** Wildlife guards (similar to a double-width cattle guard) were placed at three nearby access roads
 3 flanked by 2.4 m (8 ft) tall fencing. This deer avoided the highway with the wildlife guard and fencing in place.

14 Wildlife fencing that is about 2.4 km (1.5 mi) in length and that is 2.4 m (8 ft) tall was constructed
 15 between natural barriers to encourage and/or funnel the animals under the new bridge and prevent their
 16 wandering on the highway (Figure 12). Six escape jump-downs were built into the fencing so that animals that
 17 somehow get trapped on the highway can utilize a jump-down to escape the highway (Figure 13). The bridge
 18 was operational in the fall of 2012 but the fencing and jump-downs were not completed until August of 2013.
 19 The engineer's estimate was \$2,105,341 and the low winning bid was \$2, 113,354. The total project cost is
 20 \$3.4 million.

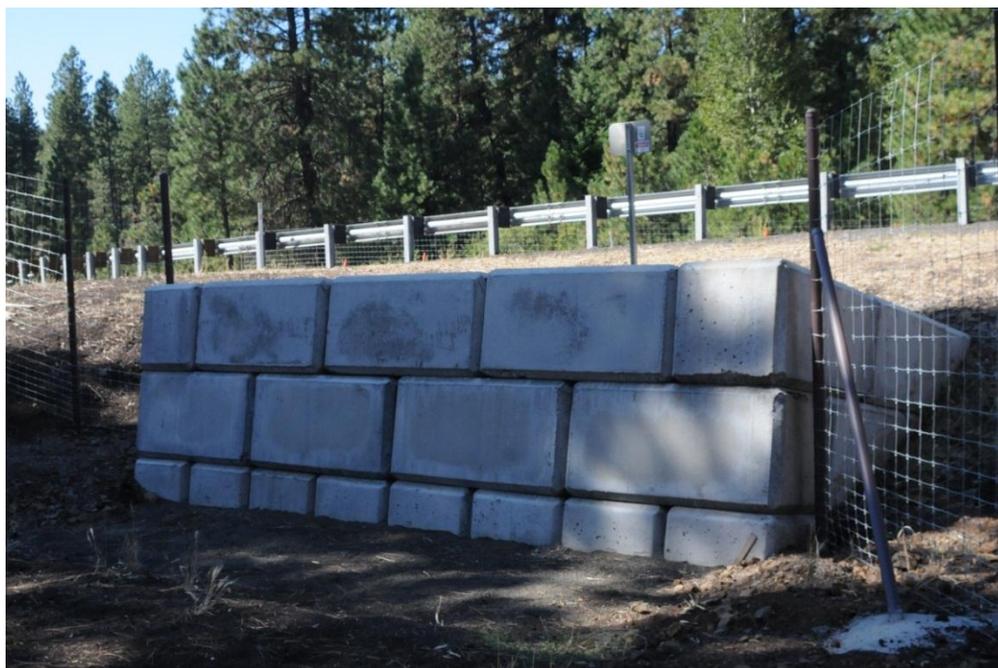
6 **FIGURE 13-** One of six jump-down structures to facilitate escape for deer trapped in the right-of-way of US 97 at
 7 Butler Creek.

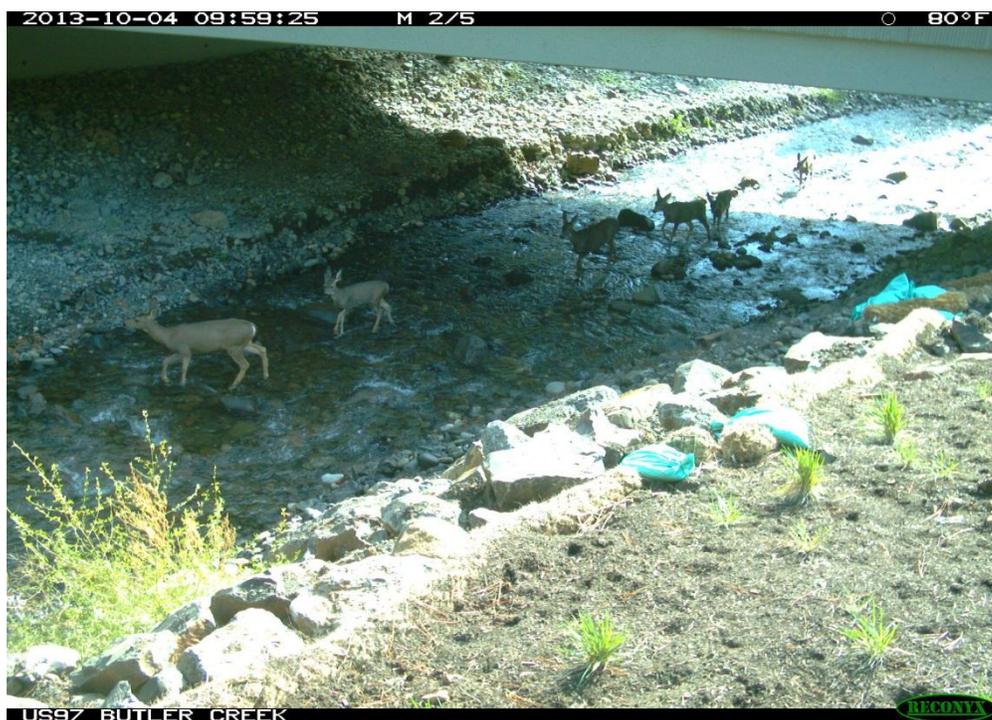
4 **FIGURE 14- Six deer crossing under the new bridge at US 97 Butler Creek near Goldendale, WA**

- 1 This creative project will undoubtedly solve an aquatic and wildlife connectivity problem with a single
 2 action (Figures 14, 15, 16).

4 Four motion triggered wildlife cameras have been placed upstream and downstream and the
 5 preliminary data is promising. A total of 101 deer crossings were observed between June 1, 2013 and
 6 September 30, 2013 for an average of 1.1 deer per day. A Great Blue Heron and a ground squirrel crossed
 7 under the bridge 5 times during this time period as well. Additional cameras have been placed at one of the
 8 jump-downs and near a road crossing with a wildlife guard. We are looking forward to reporting on our remote
 9 camera results and more in the future.

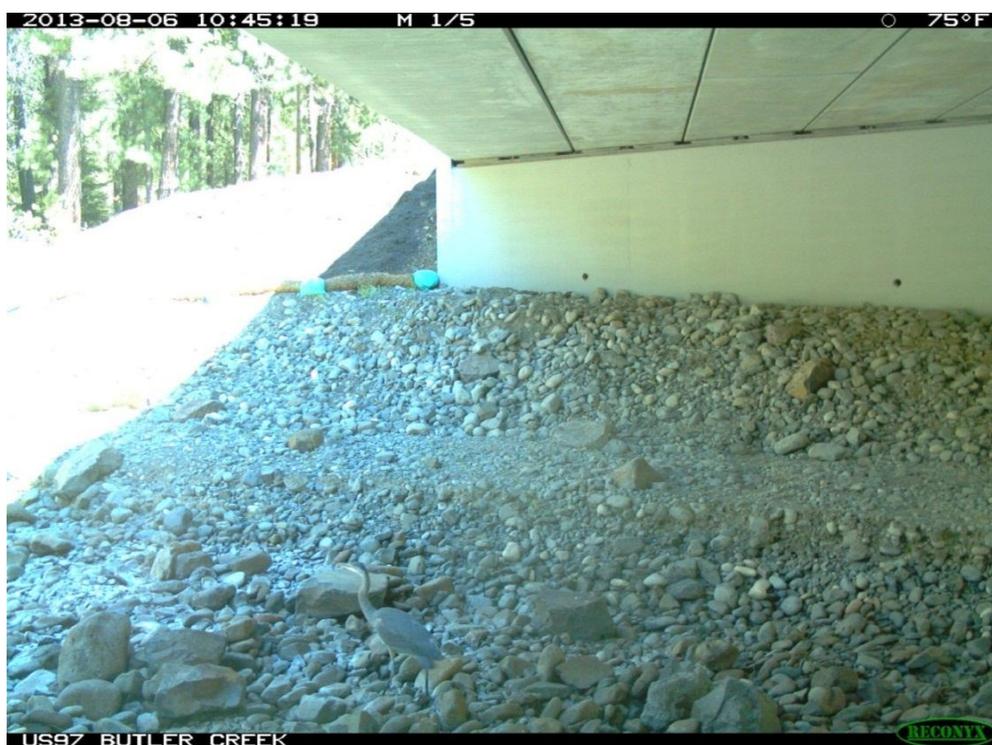
6 **FIGURE 15- A great blue heron walking the streambed under the new US 97 Butler Creek bridge.**

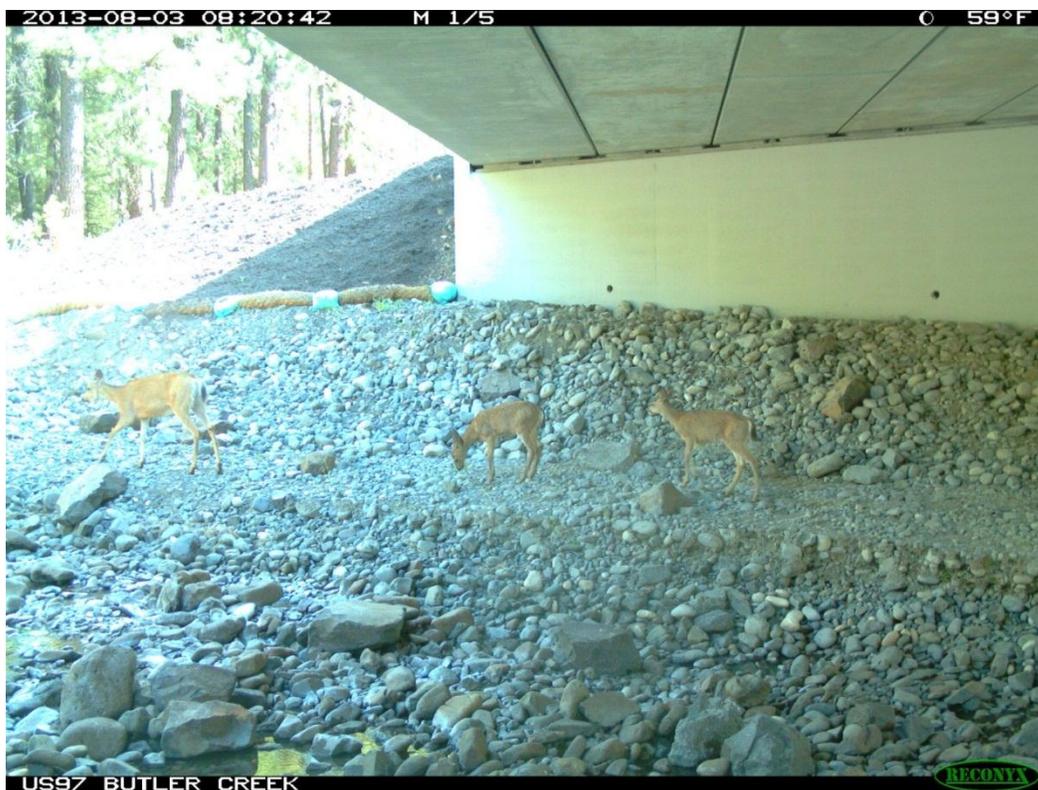
2 **FIGURE 16- A doe and two fawns utilizing the wildlife bench under the new bridge at US 97 Butler Creek at**
 3 **milepost 21.35.**
