## Large-sized Bolt-A-Plate Round provides deep-cover, washout-resilient solution for BC's Highway

A large-sized AIL Bolt-A-Plate Round with Best-Kote Polymer Coating replaced a temporary structure at Gladwin Creek on Highway 1, east of Lytton, BC, providing a durable, long-term, deep-cover solution designed to withstand future extreme weather events.

**Project Name:** Gladwin Culvert Replacement

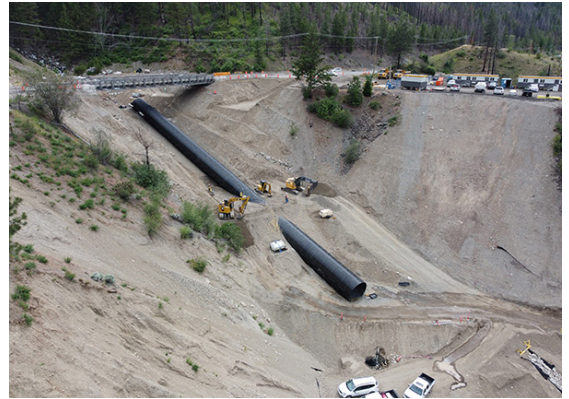
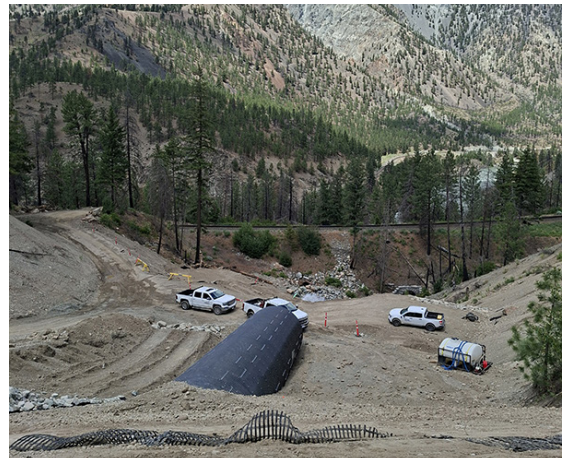
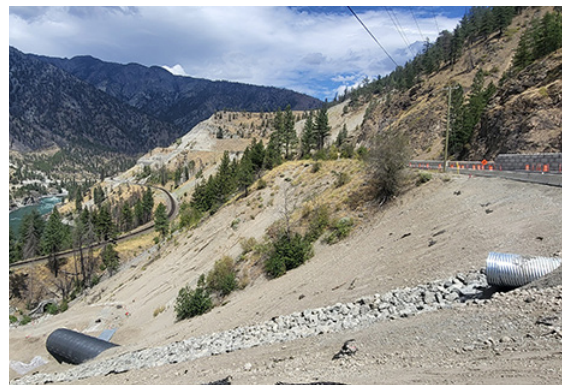
The new Bolt-A-Plate Round is sized to provide additional capacity for future extreme weather events. Its invert features a concrete lining and splash pond, while a concrete collar and debris guard at the inlet provide additional protection from the high flows and debris associated with severe weather. Best-Kote Polymer Coating was also specified to enhance corrosion protection and extend the structure's service life.

Installation on steep slopes can present challenges; on this project, grading inconsistencies along the invert created assembly issues until the slope was corrected. Backfill also required careful attention as material was placed and compacted horizontally and not in line with the structure.
