PROJECT PROFILE

AIL acts quickly to provide solution for highway washout

Name: Arnold Creek Washout Project

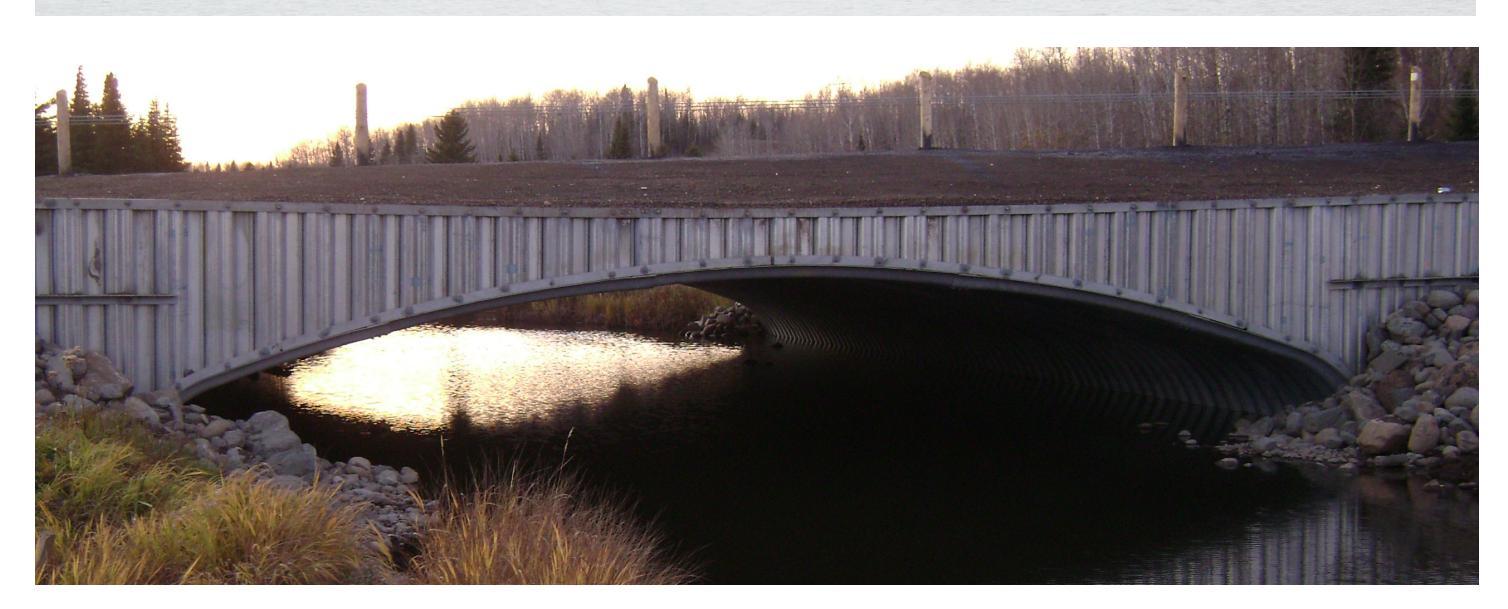
The Ministry of Transportation wanted to avoid washouts in the future. The original structure was an open-bottom, concrete box culvert which could not sustain flood-like conditions. As the water flow rose, the structure scoured and collapsed into the stream.

To avoid a similar outcome, MTO determined that the project should be completed using a Super-Cor Box Culvert with sheeting headwalls (span 14 m, rise 3 m, length 35 m). Understanding that time was of the essence, we fast-tracked the culvert's production in true design/build fashion, working very closely with the owner, the consultant and the contractor. Design took place in late June and early July and the structural plate was shipped and assembled in late July and early August.

The contractor received the culvert so quickly that they faced a unique challenge. The water levels were still very high and it was impossible to extract the water entirely, so the construction crew was forced to work while up to their knees in water to install the precast footings and attach the structure to the base channels.
