### AIL's Super-Cor and MSE Retaining Walls team up on one of Calgary's new Iuxurious community developments

## Box Culvert perfect solution: low-rise with excellent open flow hydraulic properties in case of flooding

**Project Name:** The Ridge at Sage Meadows by Genesis

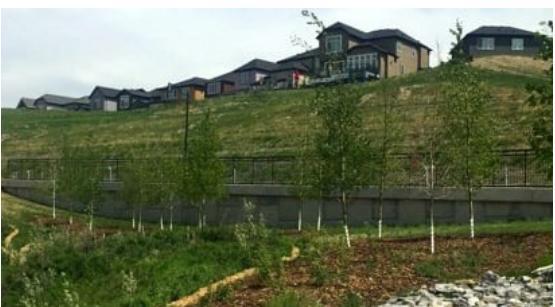
Vegetated Wall, on the slope above the Precast Wall, in its growth infancy.

There also was a Vegetated Wire-Faced MSE Retaining Wall used. This green retaining wall application has a vegetated facing using local grass seeds and foliage. This growth disguises the retaining wall itself and blends it into the natural environment surrounding it.
