Urgent bridge replacement: from site prep to first train in 120 days

Urgent project to replace a 60 m span steel girder bridge damaged during severe flooding

Name: Twin Super•Cor SC74 Arches

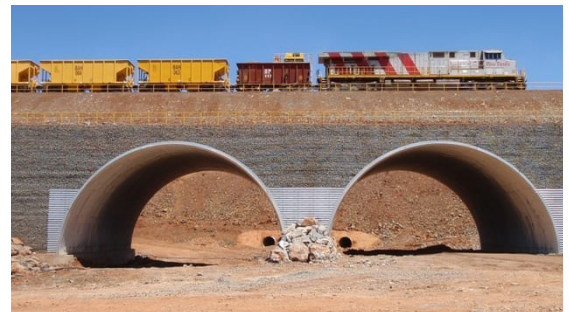
Twin Super•Cor Arches in Australia.

Dimensions: Span: 20 m, Rise: 10 m, Length: 25.2 m, Distance between: 4 m

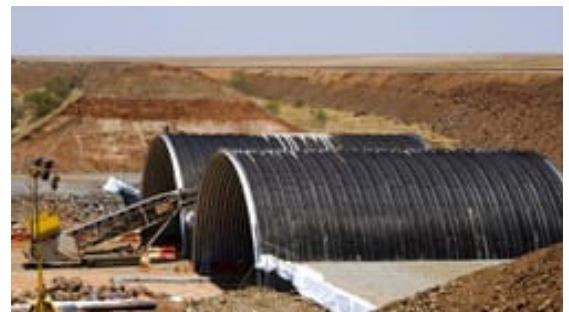
Twin Super•Cor Arches being installed.

Despite a very tight turnaround time, the components arrived on time. Both structures were built in less than three weeks, including grouting the ribs, bringing us back on schedule.

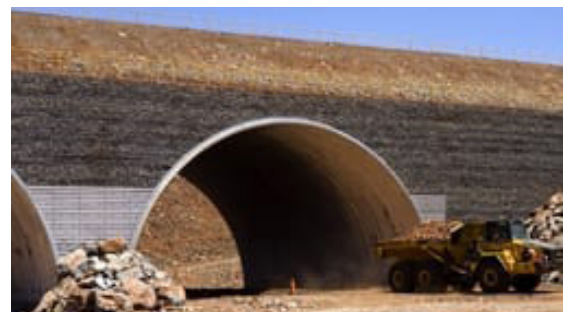
Mining vehicle passes through AIL Super•Cor Arch.
