## Super•Cor Box Culvert reconnects NL T'Railway after major washout

**Name:** Dog Brook Washout Repairs

**Product:** Super•Cor Box Culvert with MSE Wire  
Walls

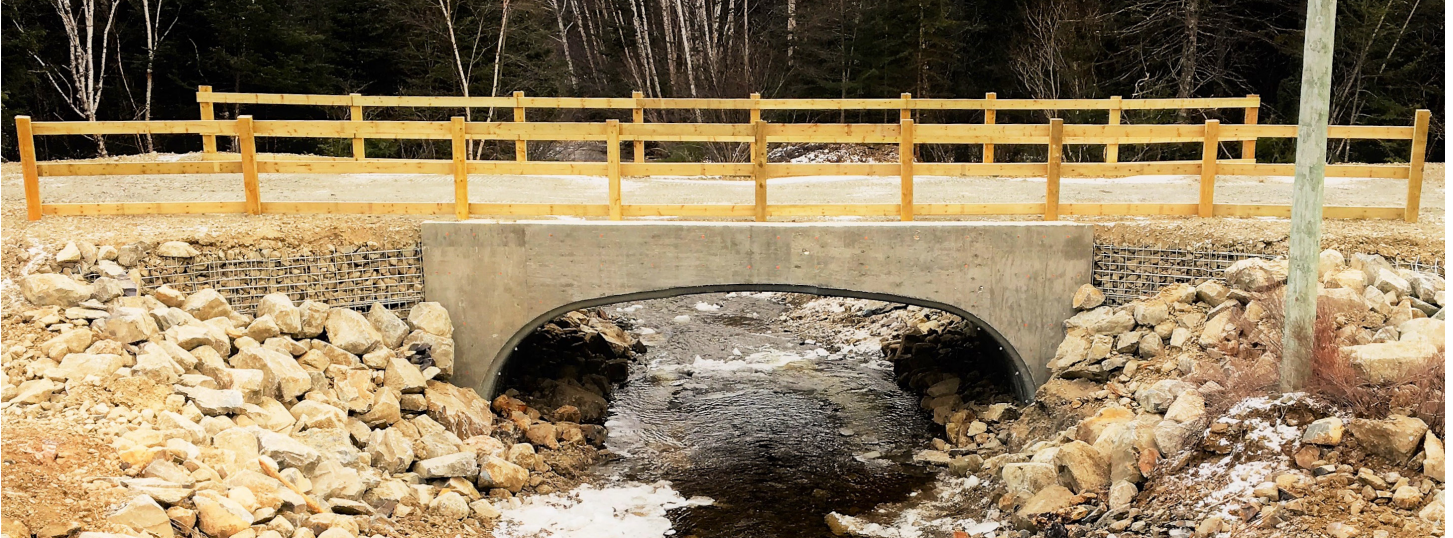
The wide-mouthed, low-rise design of the Super•Cor Box was the perfect solution to replace the smaller pipes that were prone to debris blockage and flooding. The assembled Box Culvert was set on prepared concrete footings and finished with concrete headwalls and our MSE Wire Wall wing walls.

**Dimensions:** Span 7.0 m, Rise 2.0 m,  
Length 6.1 m
