## Thunder Bay chooses Super•Cor Box Culvert with Best-Kote

**Name:** Briarwood Culvert Replacement

**Product:** Super•Cor Box Culvert SB-10L with one bevel end and one end with MSE Wire Wall Headwall

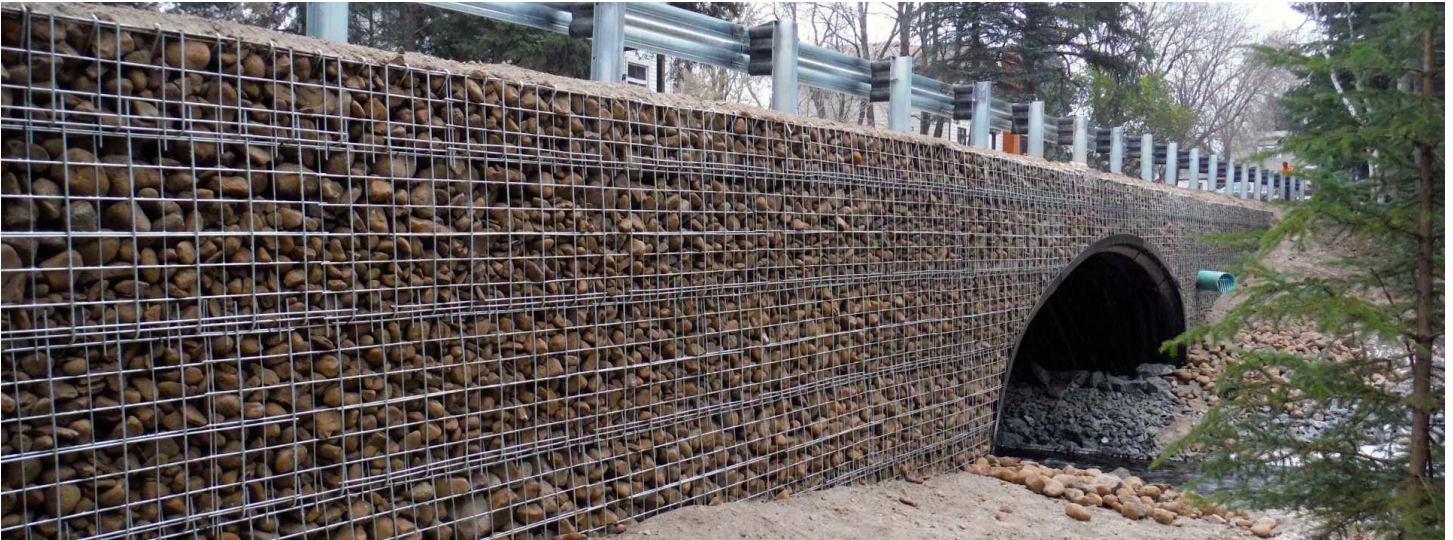
When the City of Thunder Bay, Ontario, needed to replace an aging closed-bottom culvert under Briarwood Drive, they opted for a Super•Cor Box Culvert with Best-Kote Polymer Coating so they could benefit from its 75+ years of design service life expectancy.

Plus, the geometry of the wide-mouthed (10 m), open-bottom Box Culvert offered improved hydraulic flow properties to greatly reduce the chance of any debris jams and flooding events.

**Dimensions:** Span 10 m, Rise 2.29 m, Length 14.5 m

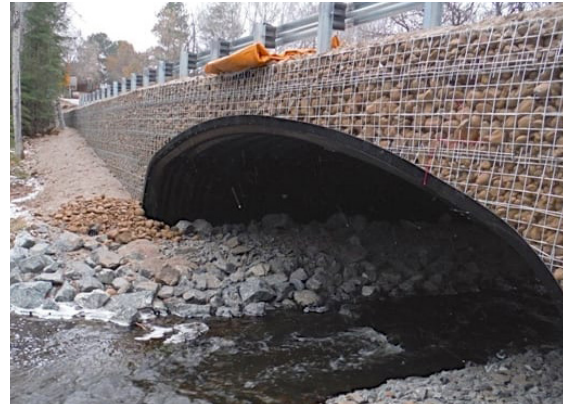
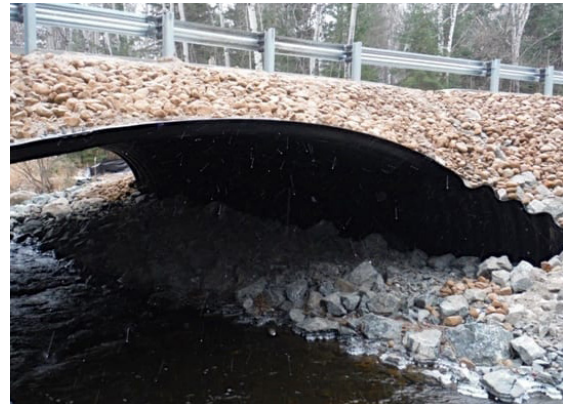
This stream crossing had an integrated MSE Wire Wall Headwall on the upstream end and a bevelled-end embankment on the downstream end. Production lead times were discussed upfront, delivery schedule was met and installation happened right away. On-site supervision was provided by AIL to aid in the installation of the structure and wire wall.
