Bolt-A-Plate Culvert ready for Northern BC extremes

Name: Grizzly Creek

Product: Bolt-A-Plate Horizontal Ellipse

Dimensions: Span 5.6 m, Rise 3.6 m

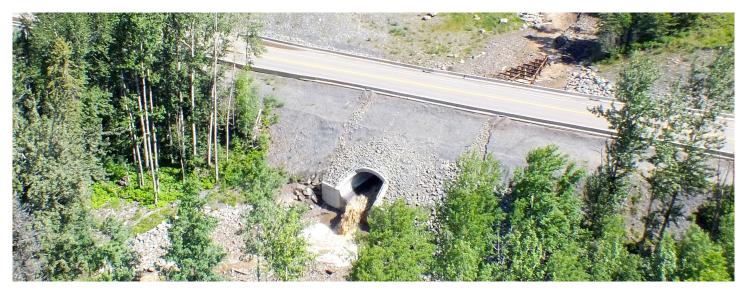
In the Peace River area of Northern British Columbia, severe flooding had completely overwhelmed a 900 mm culvert and washed out busy Highway 97 at Grizzly Creek, near Chetwynd.

The BC Ministry of Transportation and Infrastructure (BC MoTI) contracted McElhanney Consulting Services Ltd. to review crossing replacement options. For this project's accelerated construction schedule they selected a Bolt-A-Plate Horizontal Ellipse structure from AIL.
