# PROJECT PROFILE

# Super-Cor Box provides more climate change washout resilience in BC culvert-replacement project

Name: Bottom Wood Lake Road Culvert

Replacement

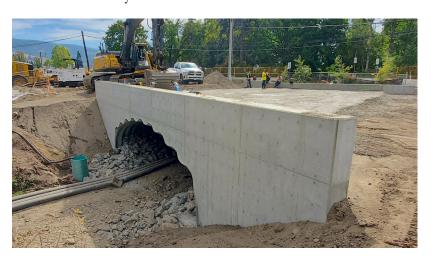
This Super•Cor Box Culvert was part of a larger infrastructure development and roundabout construction near a new high school being built in Lake Country, BC. Needless to say, there was a lot of construction activity in a small area.
